FACILITY INSPECTION REPORT

| Facility No: | M6-0493 | Fiscal Year: | 2010 |
| Facility Name: | Industrial Area Support Building | Inspection Date: | 01/10 |
| Location: | Kennedy Space Center (KSC) Industrial Area | Facility Owner: | NASA |

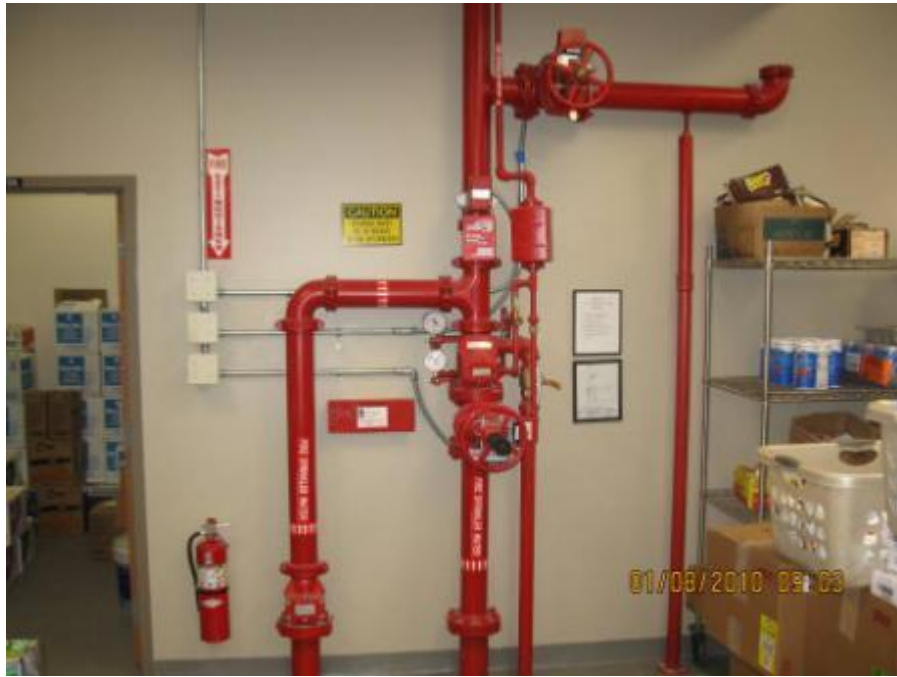
Figure 10. Wet Pipe Fire Suppression System Riser

A new wet pipe fire suppression system exists in Room 1220 located on the east side of the building (see Figure 10). This equipment should be added to Maximo with appropriate preventive maintenance. The OMEU assigns maintenance responsibility to ISC for the SY subsystem. This system was recently turned over to ISC and assignment of equipment numbers and preventive maintenance is pending.
